Manhole Inspection Summary

Manhole # S01EE2032MH

Insp Date: **7/24/06 9:51 AM**

Location Address: **6402 Cross Country Blvd**

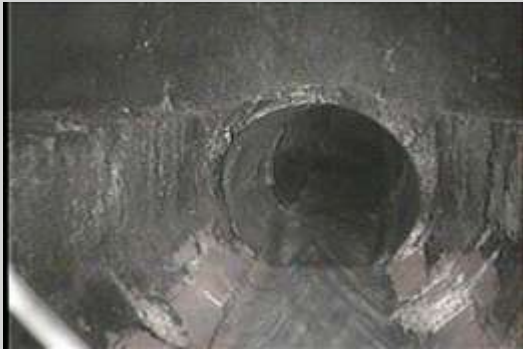
10 in. Circular Gravity Sewer Pipe Out @ 12 O'Clock

Pipe Material: **Clay** ☐ Pipe Lined

Invert Depth: **14.10** (ft.) Flow Characteristics: **Slow**

Deposits: ☒ None ☐ Mud ☐ Sludge ☐ Debris ☐ Grease

Infiltration: **None** Pipe Seal Cond: **Sound**

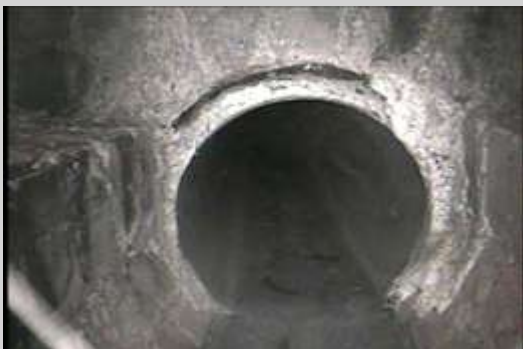
10 in. Circular Gravity Sewer Pipe In @ 6 O'Clock

Pipe Material: **Clay** ☐ Pipe Lined

Invert Depth: **14.00** (ft.) Flow Characteristics: **Slow**

Deposits: ☒ None ☐ Mud ☐ Sludge ☐ Debris ☐ Grease

Infiltration: **Evidence** Pipe Seal Cond: **Unknown**
